TROUBLE SHOOTING, MICROMAX AND VVX MOTORS

Troubleshooting, MicroMax, MicroMax180, MicroMax370, MicroMax750

Connecting and troubleshooting VVX motors

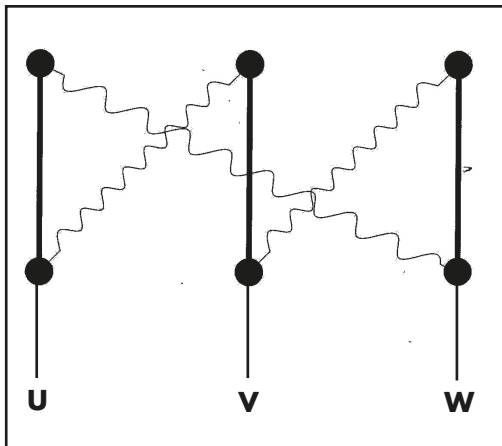
Measuring motor winding resistance

Tests should be performed using a Megger or a universal instrument to make sure that the motor windings are intact.

- Motor winding fault.
- Phase-to-phase short circuit in the cable.
- Measure motor resistance; it should be identical on all phases. (See page 8).

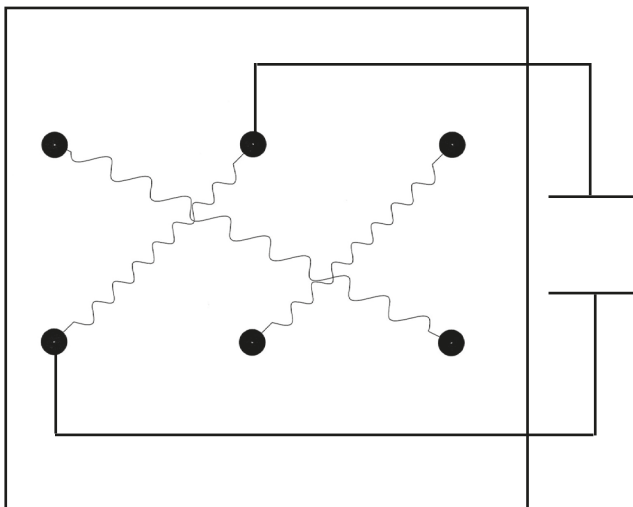
Measuring resistance

Before the test is carried out, the motor cables must be disconnected and the connection links in the motor removed.
